Measurement of Corrosive, Odorous, and Potentially Harmful Gases from Imported and Domestic Wallboard

Technical Symposium on Corrosive Imported Drywall November 5th, 2009
Tampa, FL

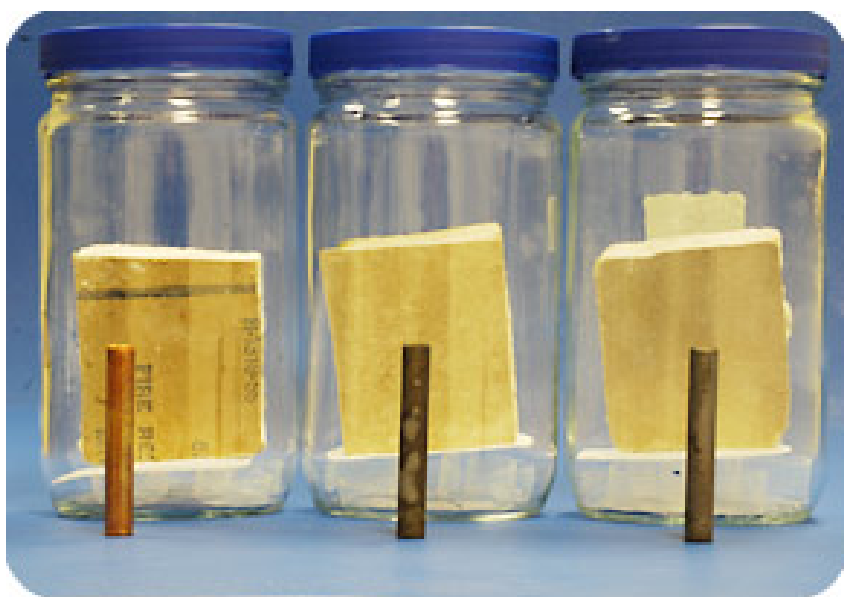
Jar Test: Blackening/Corrosion

- 3" x 3" piece of drywall on platform in 1L glass jar
- 3 mL deionized water
- 3" length of 1/4" O.D. copper tubing (lightly sanded with extra-fine sandpaper to remove surface contaminants)
- "Hot Room" at 37°C
- Blackening/Corrosion evaluation after 21 days

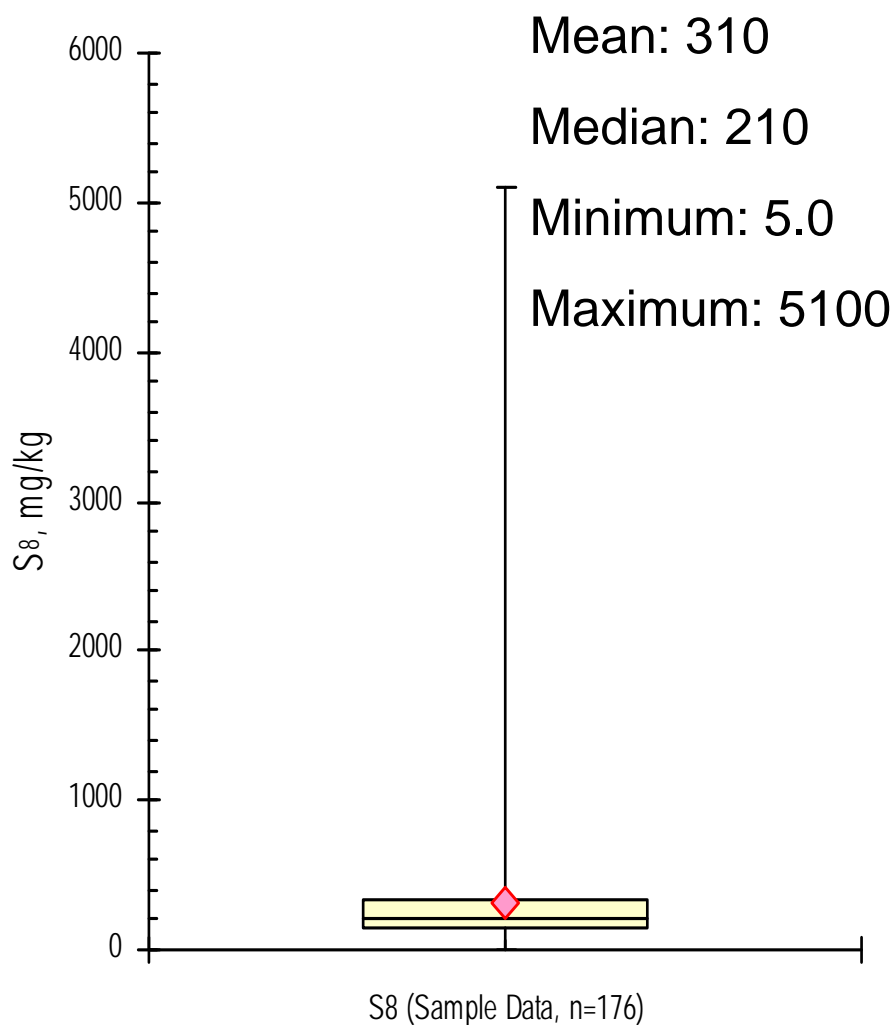
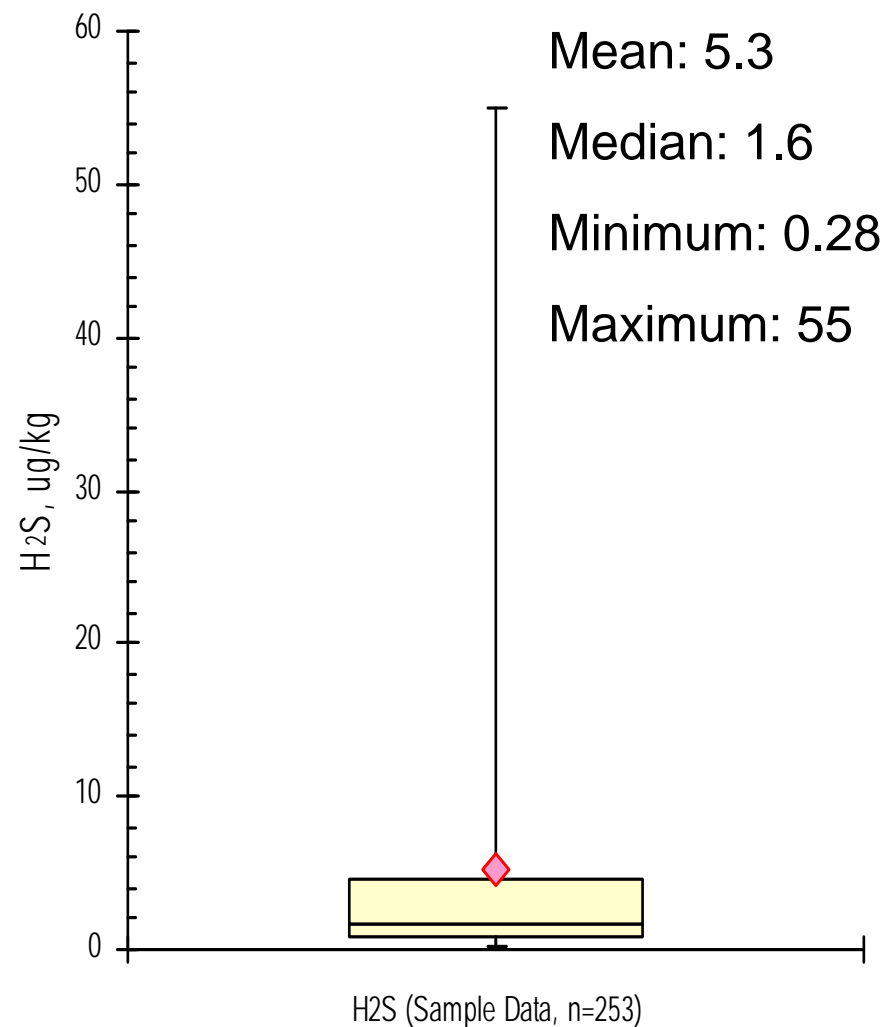
Database Summary (Positive Hits)

Compiled April 21, 2009 – October 8, 2009

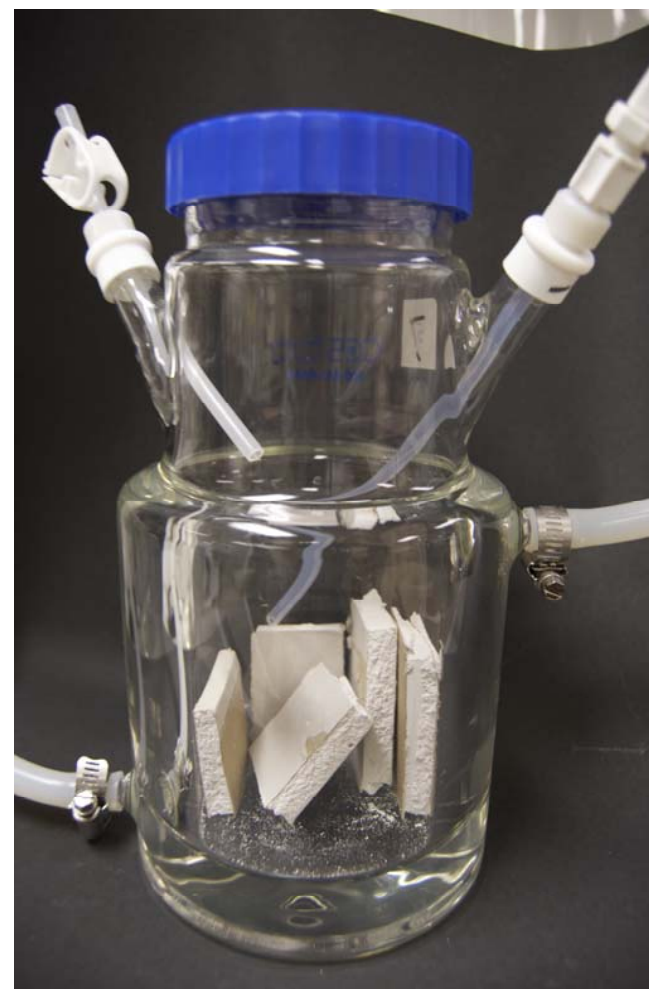
72 hour Static Chamber Studies

- Carboxylic Acids
 - In-House method (GC/MS)
- Aldehydes
 - EPA TO-11A (HPLC)
- VOCs
 - EPA TO-17 (GC/MS)
